# RIF® bushings

## The paperless, dry-type bushing technology

### 1. Introduction

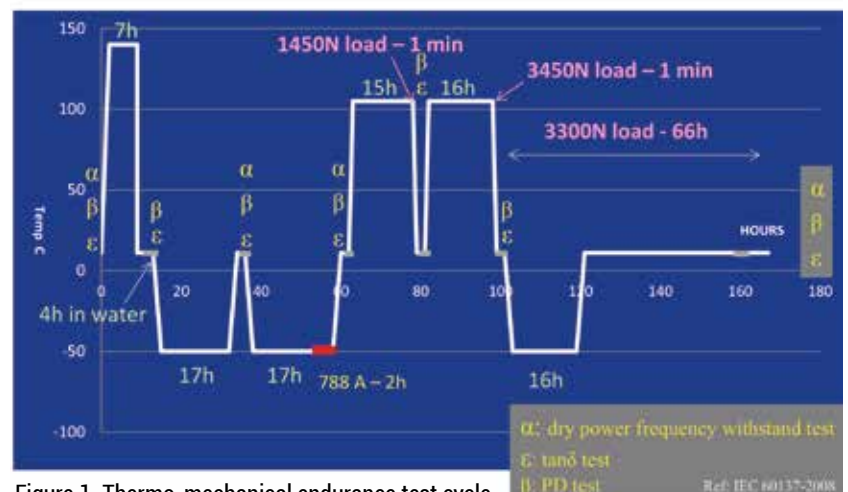
Figure 1. Thermo-mechanical endurance test cycle

RIF® bushings have a proven record of operational reliability at very low and high temperatures. All the required industry standard temperature cycling tests have been performed and passed, but to really stress this bushing technology a combined mechanical and thermal endurance stress test was carried out on a 110 kV RIF® bushing, Fig.1.

Figures 2 to 7 show the various set-ups that were used for the combined endurance test.

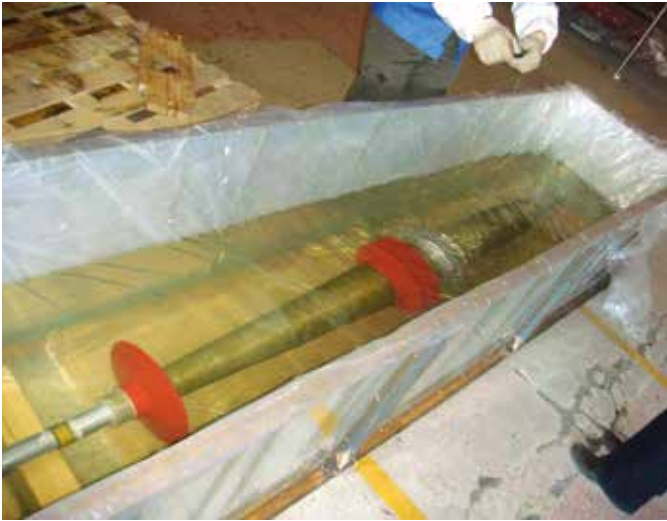
Figure 2. Thermal shock test

measured and recorded (see Table 1, Row 1). The test bushing was then placed in the environmental chamber and the temperature raised and held for 17 hours at 140 °C. After the 17 hours at 140 °C, the temperature was returned to ambient temperature and the test bushing submerged in water for four hours, Fig. 2. Upon removal from the water bath, partial discharge and dissipation factor were measured with the partial discharge values showing less than or equal to the pre-test values, and the dissipation factor remaining unchanged (see Table 1, Row 2).

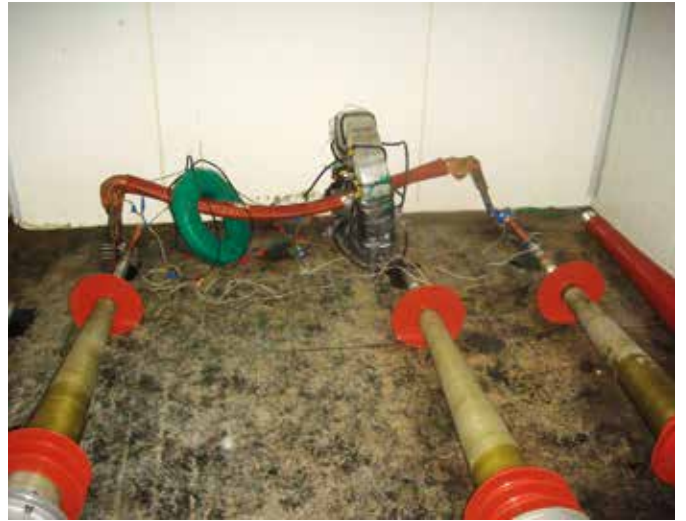
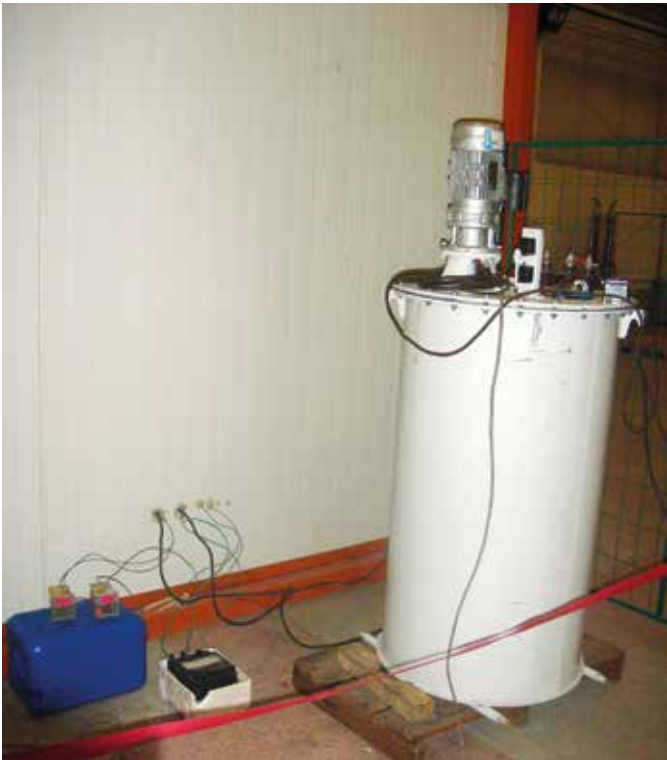
Figure 3. Low temperature test with current injection

A second 17-hour low temperature (-50 °C) cycle test was done, where 788 A was injected through the test bushing during the last two hours, Fig. 3, 4 and 7. After the current injection, the temperature

was raised to ambient temperature and a power frequency withstand test was done, with the partial discharge and dissipation factor measured (see Table 1, Row 4). The partial discharge values still remained less than or equal to the pre-test values, while the dissipation factor had reduced to 0.32 % but still remained marginally higher than the pre-test value of 0.31 %.

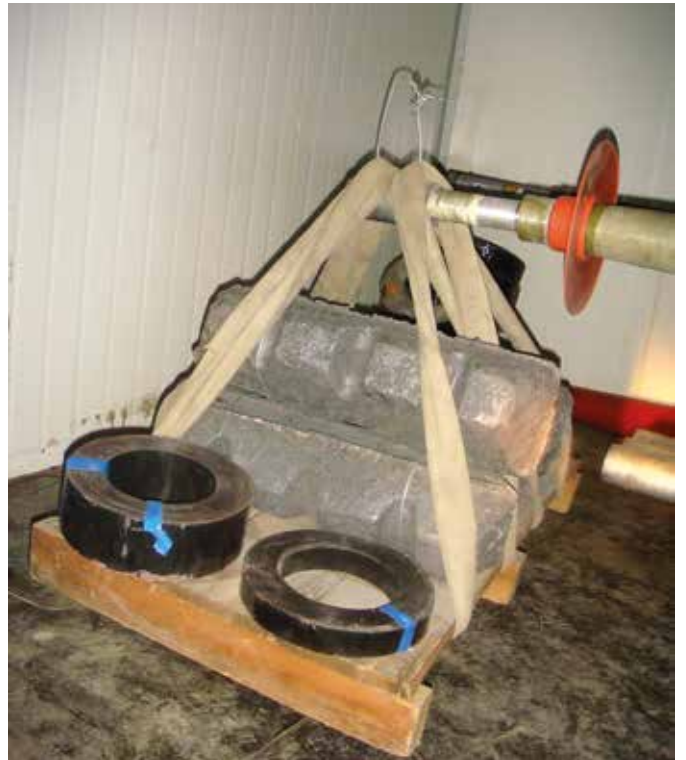
Figure 5. Cantilever load test at low temperature

The temperature was returned to ambient and then raised again to 105 °C for a second high temperature test. After 16 hours at 105 °C, a one-minute 3450 N cantilever load test was done. After the one-minute 3450 N cantilever test, a fixed load of 3300 N was maintained for the duration of the endurance test cycle, Fig. 5, which involved a third low temperature (-50 °C) cycle test for 16 hours before raising

the temperature to ambient and maintaining the 3300 N load for another 50 hours. Upon completion of the combined endurance test, a final power frequency withstand test was done, and the final partial discharge and dissipation factor values recorded (see Table 1, Row 6). The partial discharge values still remained less than or equal to the pre-test values, while the dissipation factor remained at 0.32 %, marginally higher than the pre-test value of 0.31 %.

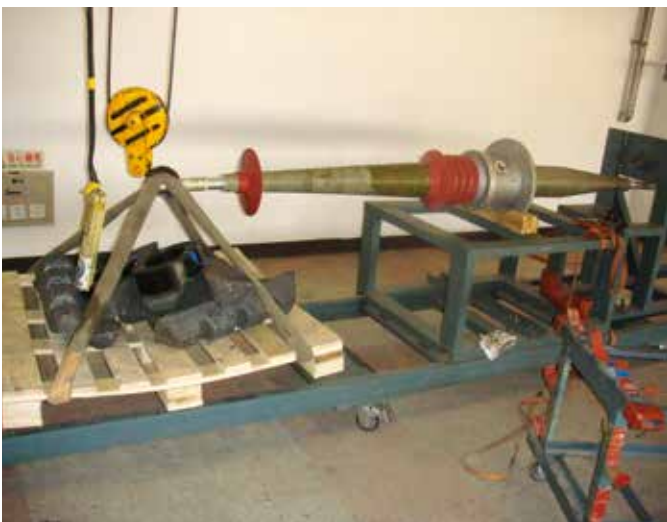
Figure 6. Heavy cantilever load test at 105 °C

The next part of the endurance test cycle raised the temperature to 105 °C. After 15 hours at 105 °C, a one-minute 1450 N cantilever load test was done, followed by a power frequency withstand test and measurement of the partial discharge and dissipation factor (see Table 1, Row 5). The partial discharge values still remained less than or equal to the pre-test values, while the dissipation factor remained at 0.32 %, marginally higher than the pre-test value of 0.31 %.

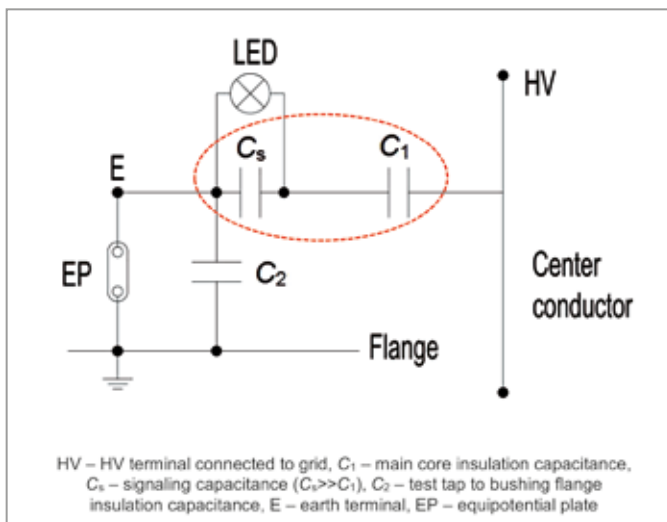
Figure 8. Smart RIF<sup>®</sup> bushing schematic representation

The smart RIF® bushing is manufactured with a large signalling capacitance  $C_s$  that is connected in series with the last capacitive screen of the high voltage  $C_1$  capacitance ( $C_s \gg C_1$ ) to form an integrated system where  $C_s$  and  $C_1$  are sealed together within the primary core, Fig. 8. The resulting capacitive divider provides an accurate way of measuring capacitance (and capacitive current) of the condenser core insulation. This is accomplished by bringing the two ends of

The main insulation of a condenser graded bushing can be thought of as a series of capacitors separating the conductor

and ground. In such a configuration, the process of insulation breakdown initiated by a defect is sequential; the insulation of one of the capacitive screens is damaged leading to the failure of other screens and eventually the breakdown of the entire insulation. As screens fail, the reduction of series connected capacitors causes a gradual increase in capacitance and capacitive current. This variation in capacitance and capacitive current can be measured to provide an indication of the degree of damage. This is the principle that is used in the smart RIF<sup>®</sup> bushing.

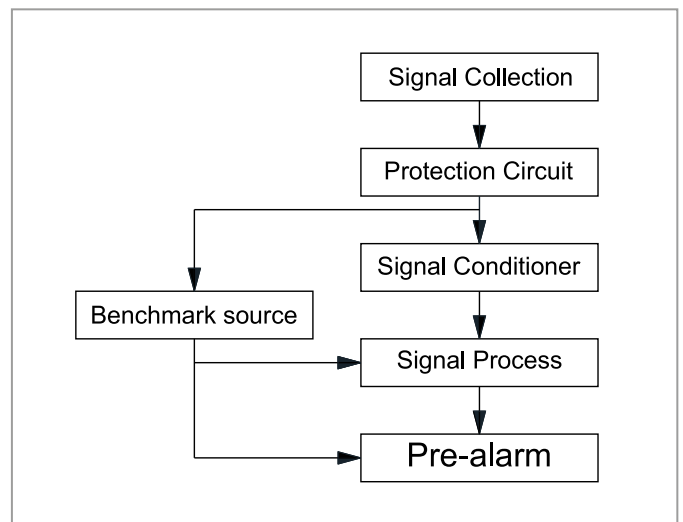
Figure 9. Pre-alarm sensor circuit diagram

$C_s$  out to a smart measurement terminal where a sensor is installed to collect and process the signal, Fig. 9. The processed signal is then compared to a benchmark voltage that is set at the factory, so no field calibration is required. The sensor is calibrated to provide a pre-alarm of a deteriorating insulation condition and is provided with two signalling options: an LED lamp for local visual indication or a signalling cable when remote monitoring is required [2].

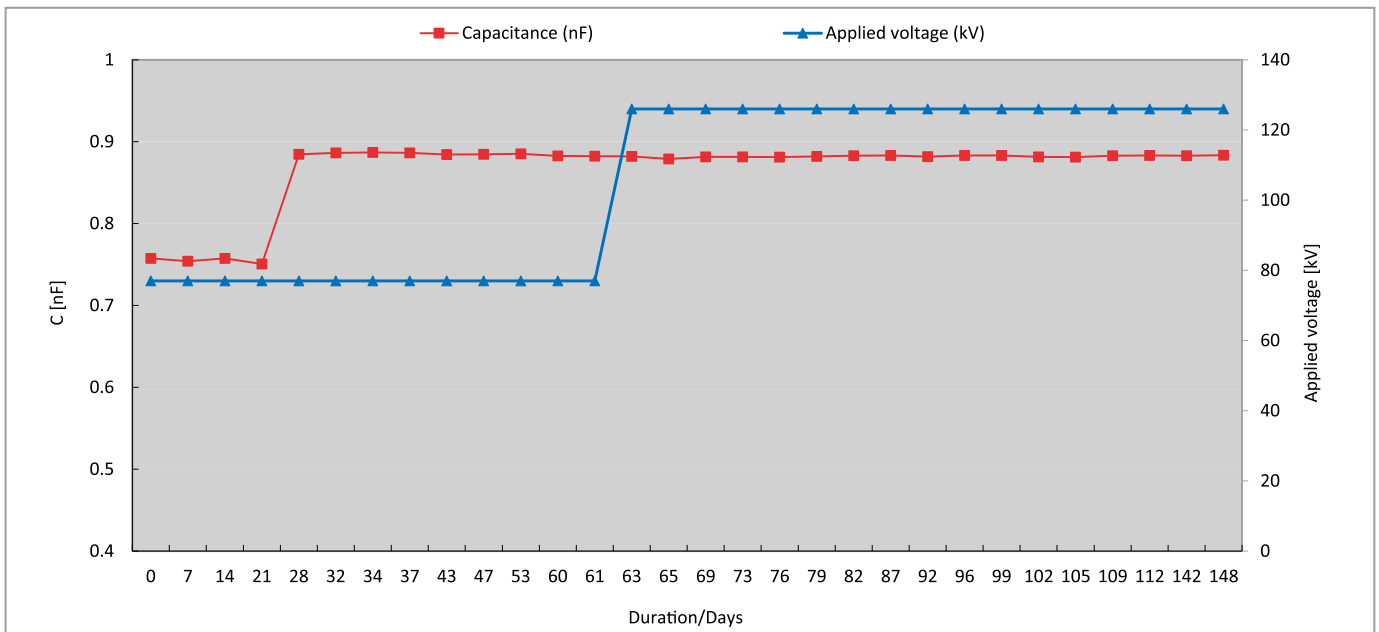
Figure 10. Test data for 126 kV RIF® bushing with artificially damaged insulation

It should be noted that the receipt of a pre-alarm signal is a very preliminary indication of the onset of a fault within the capacitive layers. The safety margins that are designed into the bushing provide a long latency period from a pre-alarm signal to when the bushing becomes unfit for operation. To validate this, lab tests were conducted on bushings that had up to 25 % of their condenser core insulation damaged using an elevated lightning impulse withstand voltage. Figure 10

shows the data from one such test on a 126 kV bushing.

The bushing which initially had 13 % of its condenser core insulation thickness damaged was energized at 77 kV for one month. After Month 1, the insulation damage was increased to 25 % which can be seen by a sharp change in capacitance, Fig. 10, and left energized at 77 kV for another month. After Month 2, the energized voltage was increased to 126 kV and the damaged bushing left energized for another three months. The test was stopped after five months with no sign of an imminent failure.

These lab tests showed that an insulation fault in a RIF® bushing propagates slowly and that even if an initial insulation fault triggers a pre-alarm, there is enough time for inspection, maintenance or replacement (at least three months).
